# Manhole Inspection Summary

Manhole # S23K1\_001MH

Insp Date: **12/1/08 1:22 PM**

**Location** Address: **2903 Mallview Rd.**

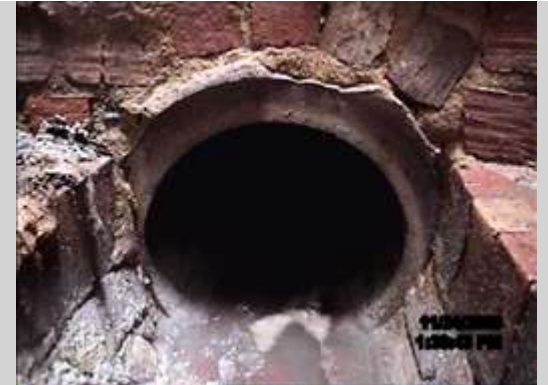
12 O'Clock Outflow

Pipe Height: **10.8** (in.) Rod and Bar (Angled)  
Pipe Material: **Clay** ☐ Pipe Lined  
Invert Depth: **9.67** (ft.) Flow Characteristics: **Slow**  
Deposits: ☒ None ☐ Mud ☐ Sludge ☐ Debris ☐ Grease  
Silt Depth: **0** (in.) Deposits Extent:  
Infiltration: **None** Pipe Seal Cond: **Sound**

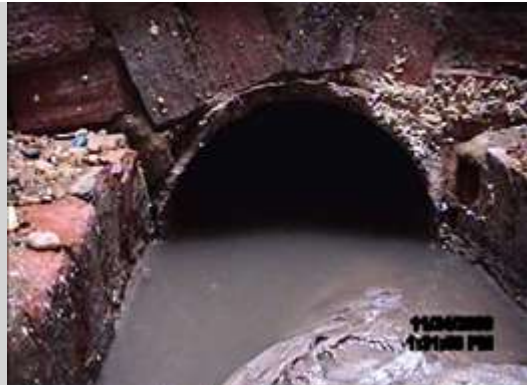
7 O'Clock Inflow

Pipe Height: **10.8** (in.) Rod and Bar (Angled)

Pipe Material: **Clay** ☐ Pipe Lined

Infiltration: **None** Pipe Seal Cond: **Sound**
